Manhole Inspection Summary

Manhole # S31I1014MH

Location Address: **37 WARRENTON RD**

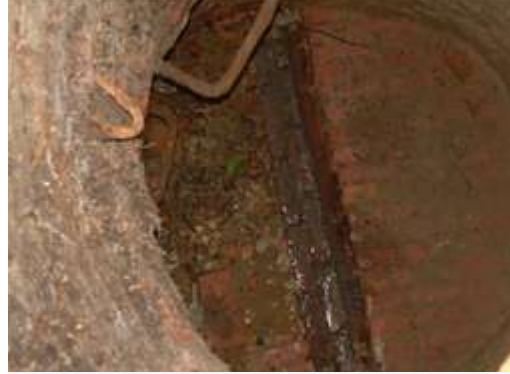
Top View

Corroded and missing steps. Bench debris.

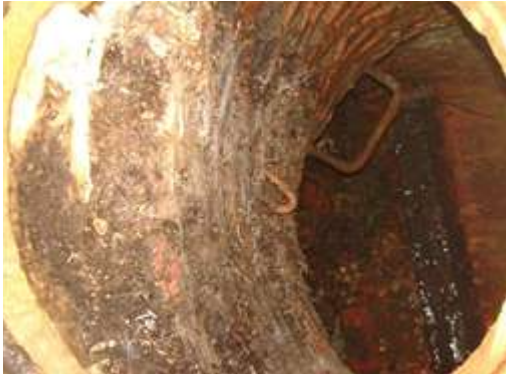
Defect

Frame Offset: **4** (in.) Condition: ☐ Sound ☐ Cracked ☒ **Leaks**

Condition: ☐ Sound ☐ Cracked ☒ **Root Intrusion** ☐ Loose Brick ☐ Deteriorated

Infiltration: ☐ None ☒ **Joint** ☐ Cracks ☐ Mortar ☒ **Roots** ☒ **Wall**

Infiltration: ☐ None ☐ Joint ☐ Cracks ☒ **Mortar** ☒ **Roots** ☒ **Wall**

Frame leaks. Frame offset. Adjustment and Corbel root intrusion and infiltration. Barrel infiltration.

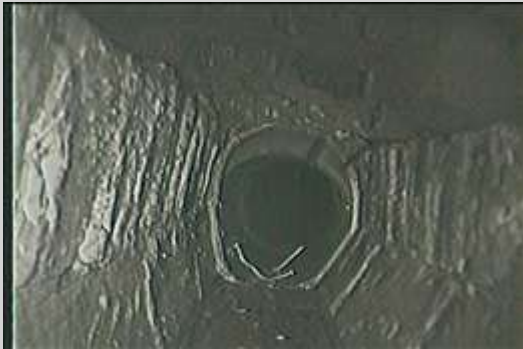
8 in. Circular Gravity Sewer Pipe Out @ 12 O'Clock

Pipe Material: **Unknown** ☒ Pipe Lined

Invert Depth: **9.20** (ft.) Flow Characteristics: **Slow**

Infiltration: **None** Pipe Seal Cond: **Unknown**

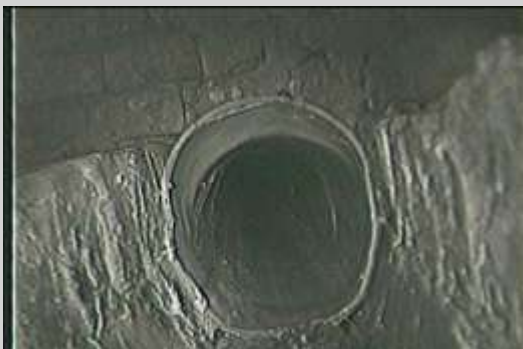
8 in. Circular Gravity Sewer Pipe In @ 6 O'Clock

Pipe Material: **Unknown** ☒ Pipe Lined

Invert Depth: **8.85** (ft.) Flow Characteristics: **Slow**

Infiltration: **None** Pipe Seal Cond: **Unknown**
